Harmalière and Avignonet Landslides

Topic: Two major slow-moving landslides affected by different processes in the same glacio-lacustrine clays

Stakes: Vulnerability/damage to buildings and infrastructures; maintenance of a residential area/expropriation

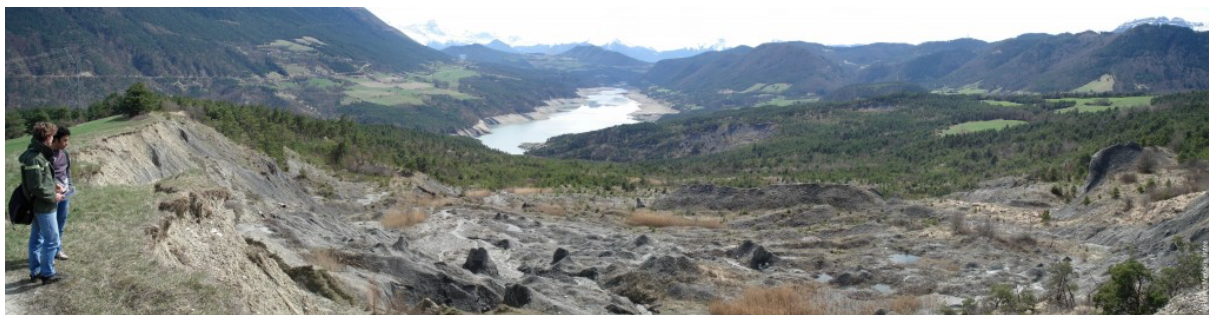
View of the Harmalière landslide from the headscarp © P. Mériaux

The Harmalière landslide is 1450m long and affects an area of around $1.8 \times 10^6 \text{ m}^2$ with an estimated volume of 25.10^6 m^3 , with a mean slope of 9° . It is a clay compound slide in its upper part, exhibiting back-tilted blocks and horst-and-graben structures, and an earthflow with smooth morphology and a flow-like pattern in its lower part. It has a long history of activity and has undergone major retrogressions in 2016 and 2017. Short-term stakes include agricultural land use and an electrical network. In the mid-term, considering the regressive mean rate, the south of the village Sinard might be concerned with stability problems.

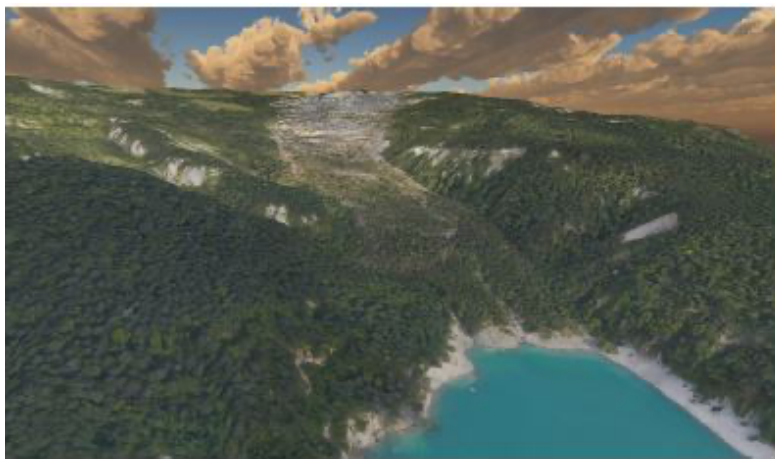
View of the Harmalière landslide constructed using a LiDAR DEM and orthorectified photographs © ISTERre/UGA, 2016

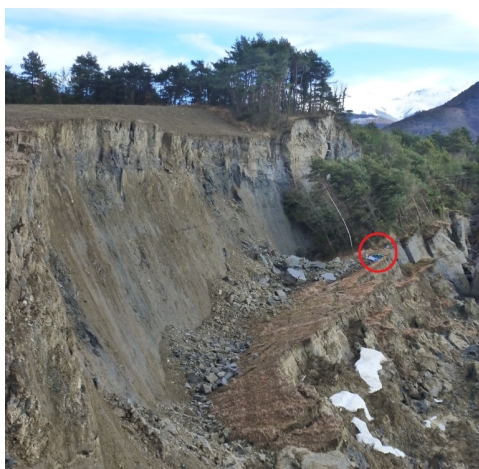
29/01/2017, the Harmalière landslide pushed away some geophysical equipment (in the red circle) ; the scarp is 10 to 15m high © Mickael Langlais
